**Flood Control Project Maintenance
Levee Inspections**
LMA District Cover Sheet
Spring 2017 Levee Inspection Results

Madera County FCWCA

**Flood Control Project Maintenance
Levee Inspections
Unit Cover Sheet
Spring 2017 Levee Inspection Results
Madera County FCWCA**

Waterway			Bank	Unit Miles
Unit No. 01 Ash Slough			Right	2.37
	Spring (March - May)	Summer (June - August)	(September - November) Fall	Winter (December - February)
Unit Maintenance Rating (Fall Only)				
Date of Inspection	5/4/2017 - 5/4/2017			
DWR Inspector	Herman Phillips			
Accompanied By

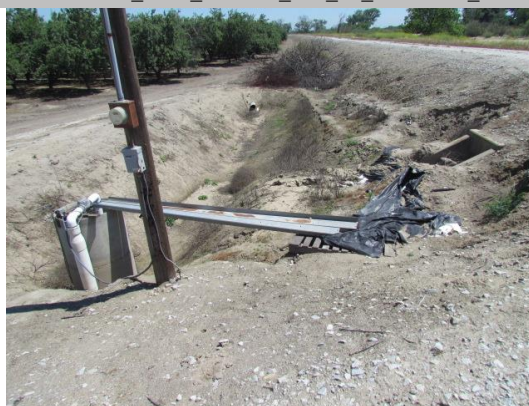
Photo 1 of 1 : SP_2017_NA0011_142_18_20170508_00020.jpg

LM Start	0.03	Rating **	U	Issue No.	18
LM End	0.06	Issue Type +	En	Location *	LS
Category	Earthen Levee			GPS Latitude/Longitude	
				Start	End
Item	Encroachments			37.046566 °	37.046715 °
				-120.427512 °	-120.426964 °
DWR ID	DWR_NA0011_01_s_2014_18				
Comment Code					
DT : Ditch					
Inspector Comment					
There seem to be lots of activity going on at this location. This ditch will cause more damage to the levee slope and toe.

Ash Slough looking upstream from the landside slope levee mile 0.03.

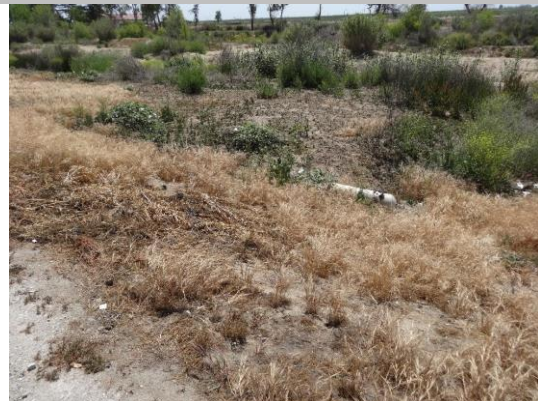
Photo 1 of 3 : UCIP_SP_2017_49976_69674.jpg

Comment Code					
Inspector Comment					
FS_ID:49976 DS_ID:21513 EP_NO: N/A Repair Type: Urgent Crossing Status: Found UCIP Comments: 7/14/2016 No inspection completed--need to inspect October 2016. (DWR UCIP - omagana)5/06/2014 Landward slope has been excavated and a berm built in front of landward headwall. Sediment visible inside pipe from landward side. Dense vegetation limits the inspector's visibility to identify signs of pipe failure (leaks) along the waterward slope. Recommend removing vegetation along pipe alignment and waterward headwall to conduct proper inspection of structure. (DWR UCIP - omagana) FIELD_STRUCT_DESC: 30-inch corrugated metal drainage pipe through the levee, 9.5 feet below the crown. Headwalls and wingwalls are located on both waterside (WS) and landside (LS) ends. Flap gate is located on the WS end. [Additional Reference(s): DWR Levee Log, 2005] FS Date: 7/14/2016

View of WS--dense vegetation along WS slope.

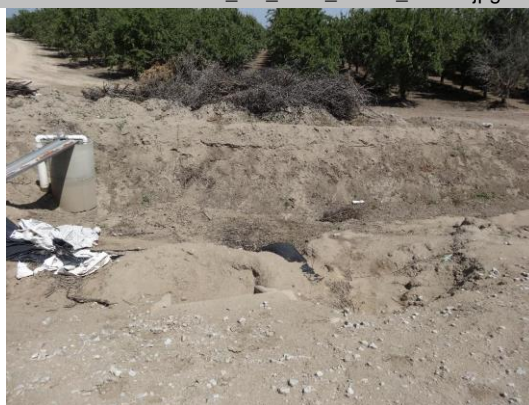
Photo 3 of 3 : UCIP_SP_2017_49976_69675.jpg

View of LS--levee slope has been modified.

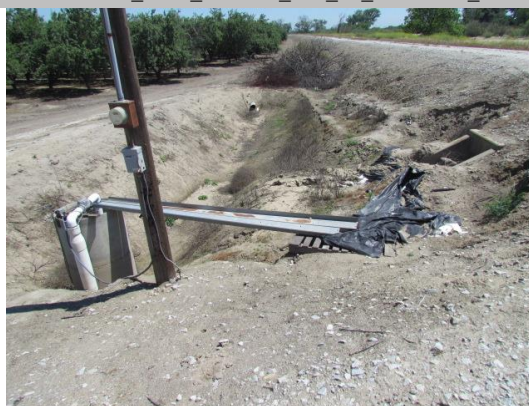
Photo 1 of 1 : SP_2017_NA0011_142_20_20170508_00023.jpg

LM Start	0.04	Rating **	U	Issue No.	20
LM End	0.05	Issue Type +	Ma	Location *	LS
Category	Earthen Levee			GPS Latitude/Longitude	
				Start	End
Item	Slope Stability			37.046624 °	37.046682 °
				-120.427317 °	-120.427108 °
DWR ID	DWR_NA0011_01_s_2014_20				
Comment Code					
S1 : Repair slope instability.					
Inspector Comment					
This is not a new erosion site, it should be repaired before the condition get any worse.

There is damage to the landside levee slope next to the concrete inlet structure.

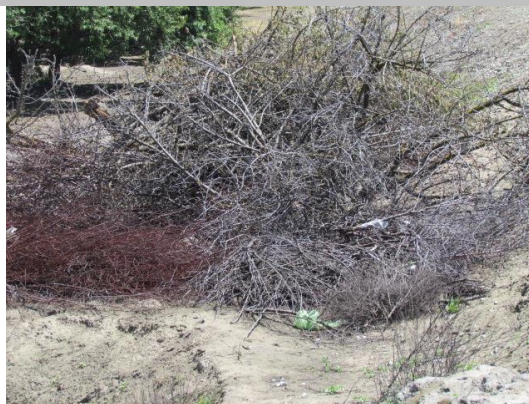
Photo 1 of 1 : SP_2017_NA0011_142_12_20170508_00024.jpg

Unwanted brush pile on the landside levee toe.

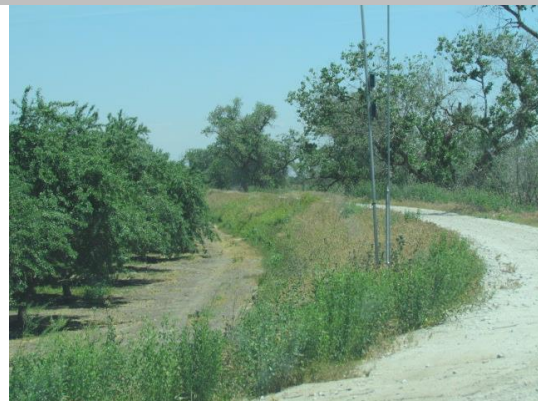
Photo 1 of 1 : SP_2017_NA0011_142_22_20170508_00026.jpg

Looking upstream from the landside slope there is landscaping planted at this location but its very weedy.

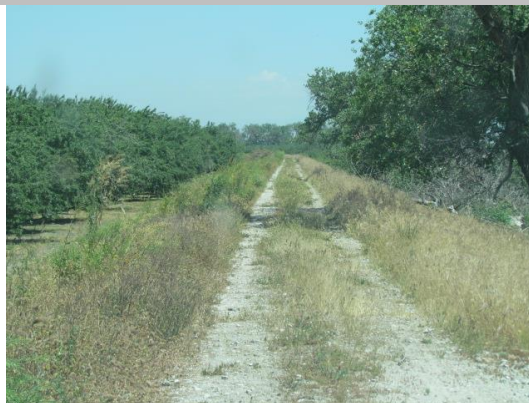
Photo 1 of 1 : SP_2017_NA0011_142_25_20170508_00025.jpg

Unwanted vegetation on the crown roadway.

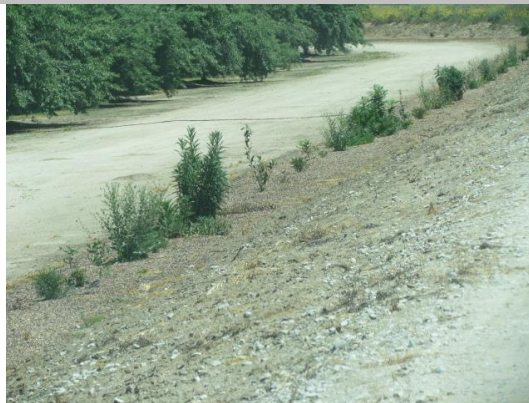
Photo 2 of 3 : SP_2017_NA0011_142_28_20170508_00028.jpg

Unauthorized landscaping continues.

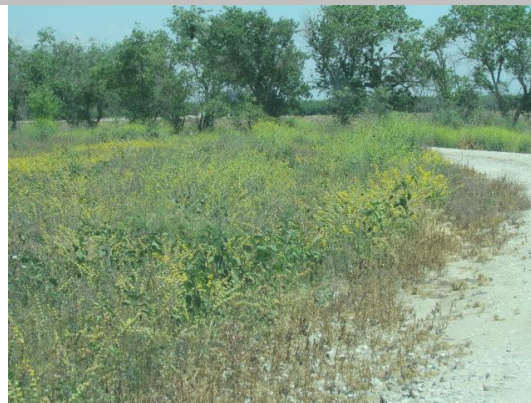
Photo 1 of 1 : SP_2017_NA0011_142_31_20170508_00030.jpg

Unwanted tall weed growth on the landside shoulder and slope.

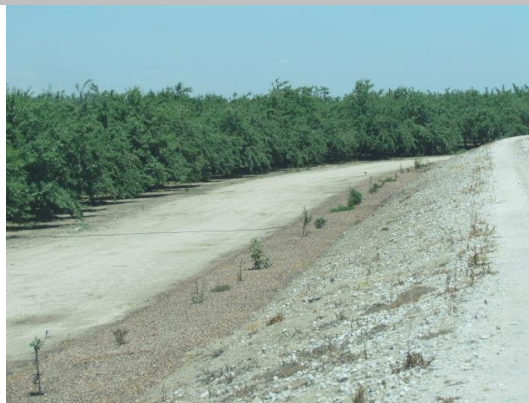
Photo 1 of 1 : SP_2017_NA0011_142_32_20170508_00031.jpg

Levee mile 1.25 to 2.07 unauthorized landscaping on the landward berm.

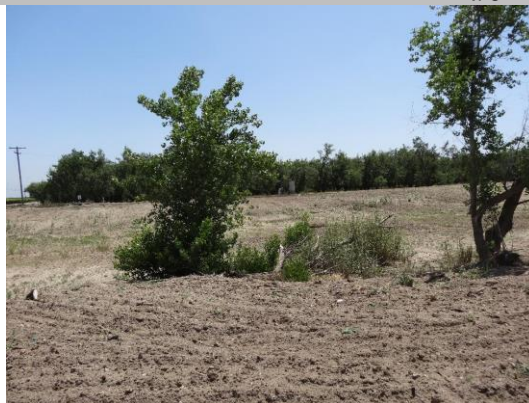
Photo 1 of 3 : UCIP_SP_2017_38226_69679.jpg

LM Start	2.37	Rating **	M	Issue No.	49
LM End	2.37	Issue Type +	En	Location *	WS
Category	Supplemental			GPS Latitude/Longitude	
				Start	End
Item	DWR UCIP Field Study			37.068763 °	37.068763 °
				-120.398523 °	-120.398523 °
DWR ID					
Comment Code					
Inspector Comment					
FS_ID:38226 DS_ID:21512 EP_NO: N/A Repair Type: Non-Urgent Crossing Status: Found UCIP Comments: Unable to determine details of crossing and whether crossing has been abandoned. Need to find owner and determine the alignment of crossing to confirm if pipe is being extended from opposite levee. FIELD_STRUCT_DESC: Abandoned service pole, pump and two 36-inch standpipes on landward side. Pump not found in 2014 inspection. Three stand pipes found on landward side. FS Date: 5/6/2014

View of waterward side.

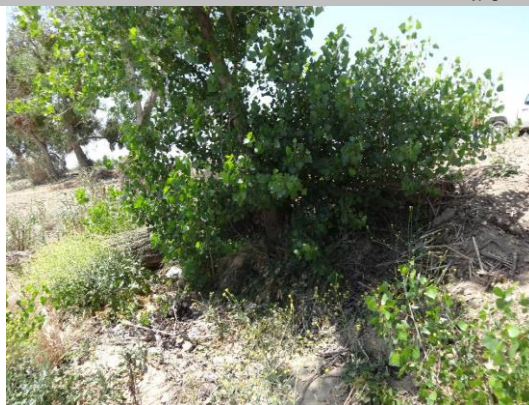
Photo 2 of 3 : UCIP_SP_2017_38226_69678.jpg

View of waterward slope--no signs of crossing visible.

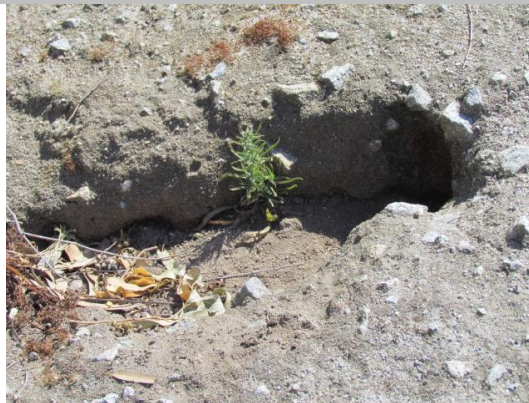
Photo 2 of 2 : SP_2017_NA0011_143_39_20170508_00039.jpg

Other rodent holes noted in the slope waterside levee section.

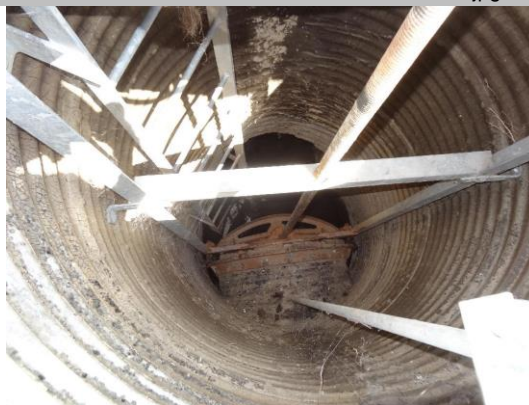
Photo 2 of 3 : UCIP_SP_2017_39686_71661.jpg

View of riser located on waterward side.

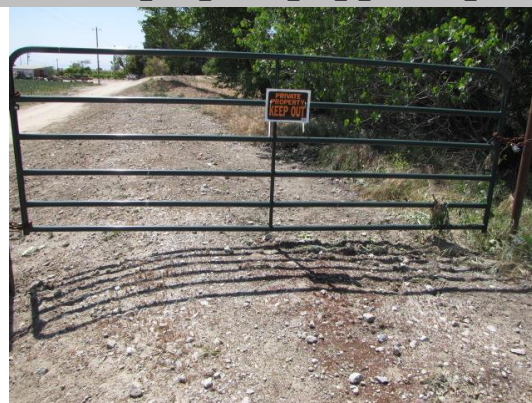
Photo 1 of 2 : SP_2017_NA0011_143_5_20170404_00004.jpg

Unauthorized gate and metal fence placed on slope and toe of levee section. Photo taken 4-17-2013.

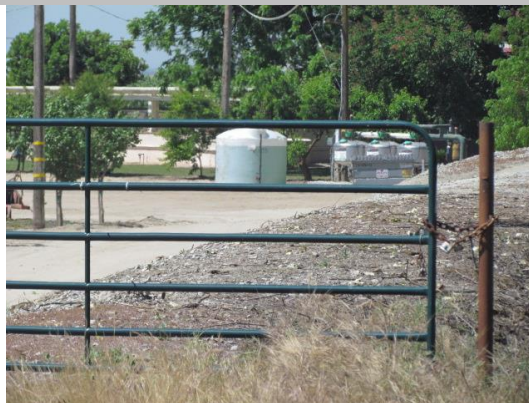
Photo 2 of 2 : SP_2017_NA0011_143_5_20170508_00040.jpg

New photo 5-4-2017.

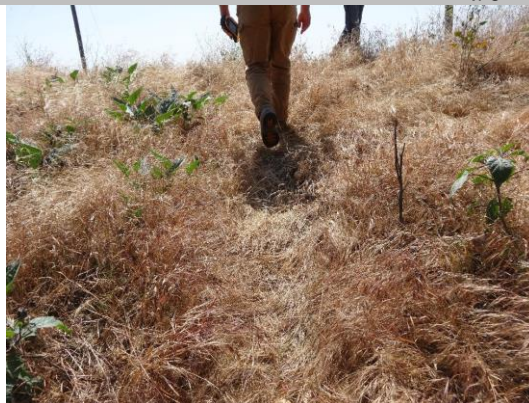
Photo 3 of 3 : UCIP_SP_2017_35764_64465.jpg

Dense vegetation on waterward slope.

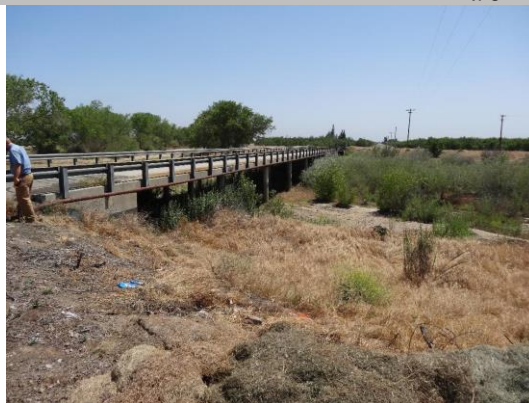
Photo 1 of 3 : UCIP_SP_2017_39923_71823.jpg

Conduit along face of bridge.

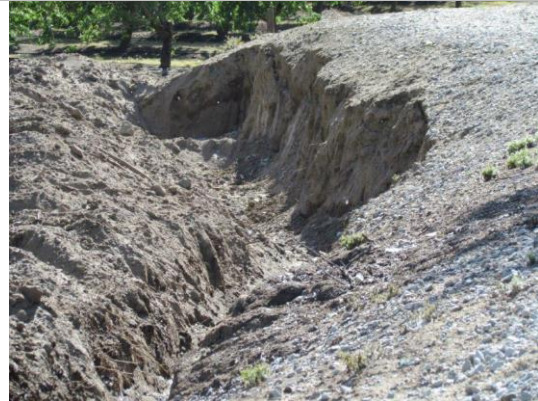
Photo 2 of 3 : UCIP_SP_2017_49978_75227.jpg

View of cut on LS slope of U2 at LM 1.49 (most downstream end of the open trench, photo 1 of 2).

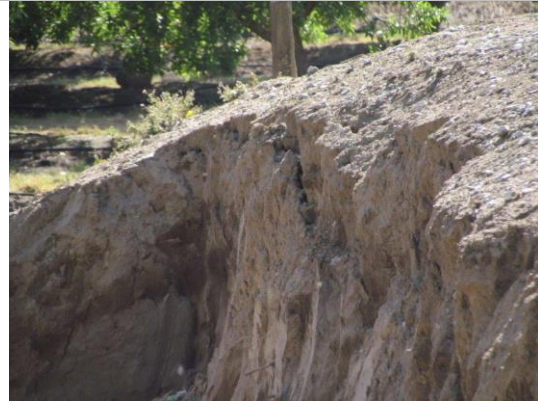
Photo 3 of 3 : UCIP_SP_2017_49978_75224.jpg

Close-up view of cut on LS slope at U2 LM 1.49 (the most downstream end of open trench, photo 2 of 2)

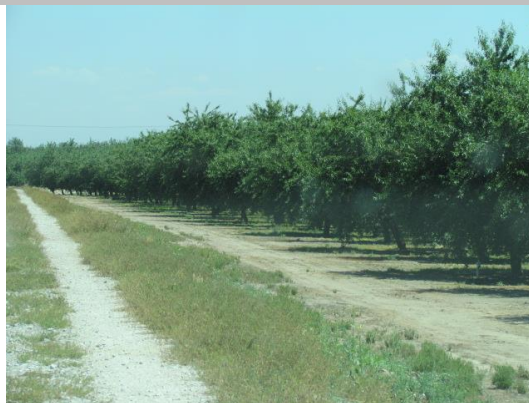
Photo 1 of 1 : SP_2017_NA0011_143_38_20170508_00044.jpg

Looking upstream from levee mile 1.66-2.00 tall weeds present on the landside slope.

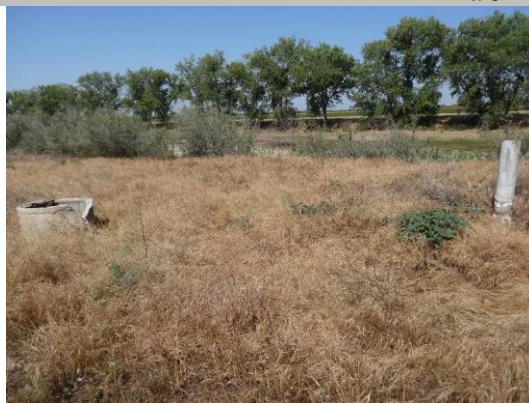
Photo 1 of 3 : UCIP_SP_2017_39925_71815.jpg

Standpipes visible on waterward side.

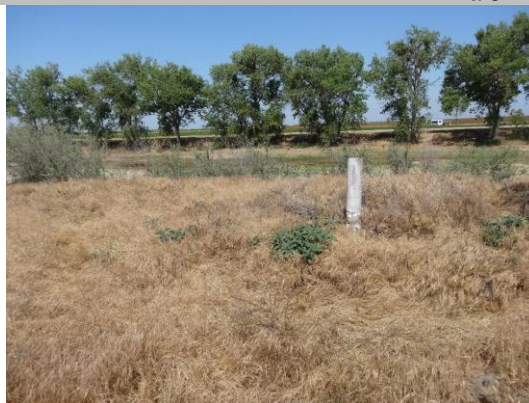
Photo 1 of 3 : UCIP_SP_2017_39924_71809.jpg

Tall concrete standpipe visible on waterward side.

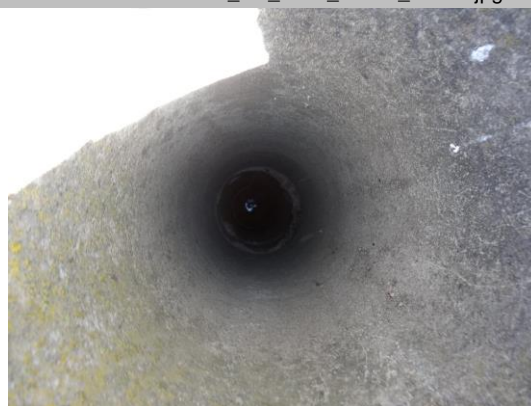
Photo 3 of 3 : UCIP_SP_2017_39924_71807.jpg

Inside view of 10-inch concrete standpipe.

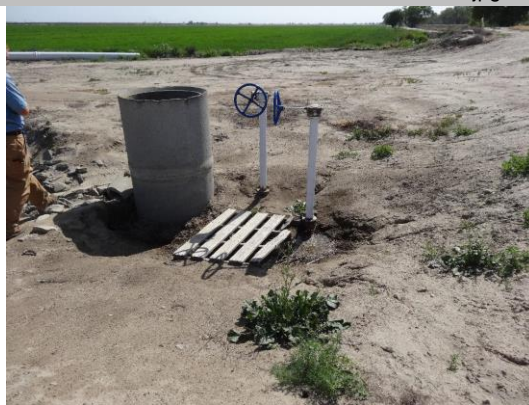
Photo 2 of 3 : UCIP_SP_2017_35767_64475.jpg

Close up of concrete standpipe and multiple positive closure devices.

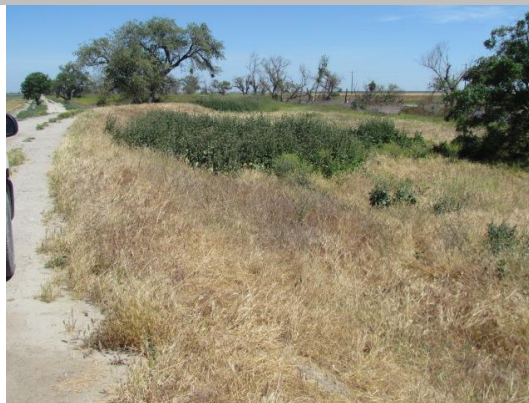
Photo 1 of 1 : SP_2017_NA0011_144_9_20170509_00016.jpg

Looking upstream from the waterside shoulder wild growth covering slope and toe.

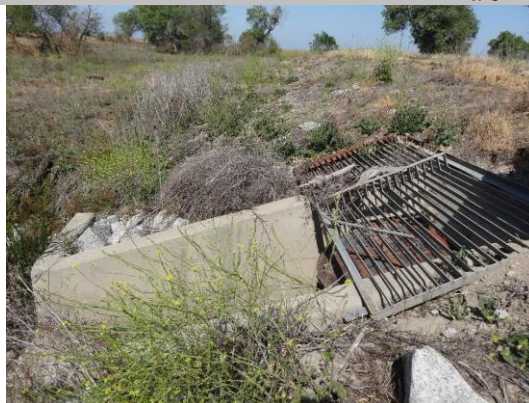
Photo 2 of 3 : UCIP_SP_2017_38228_69687.jpg

Debris screen visible on waterward headwall.

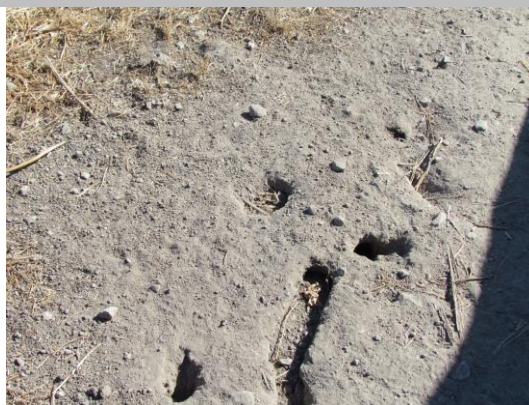
Photo 2 of 2 : SP_2017_NA0011_144_6_20170404_00005.jpg

More active rodents holes and foot traffic seen around holes though no rodents observed.

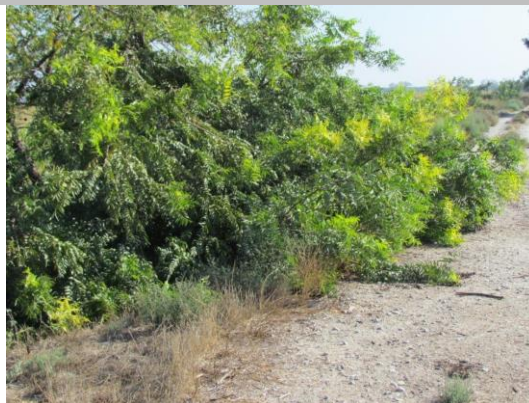
Photo 1 of 2 : SP_2017_NA0011_144_11_20170404_00007.jpg

Berenda Slough Unit 3 looking upstream from levee mile 1.04-1.05 walnut trees blocking the view of the landside levee section.

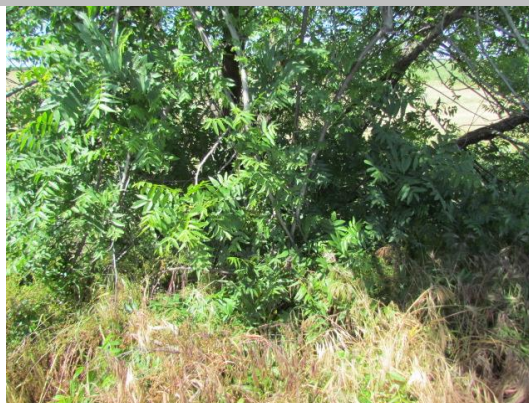
Photo 1 of 1 : SP_2017_NA0011_144_17_20170509_00019.jpg

Looking upstream from landside slope tree has blocked view of the slope and shoulder.

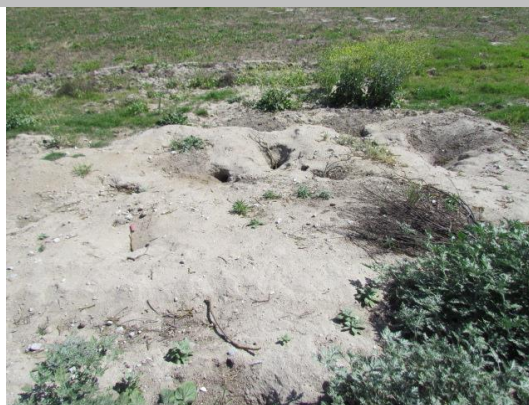
Photo 3 of 3 : SP_2017_NA0011_145_11_20170511_00023.jpg

Looking upstream at rodent activity on landward slope and toe.

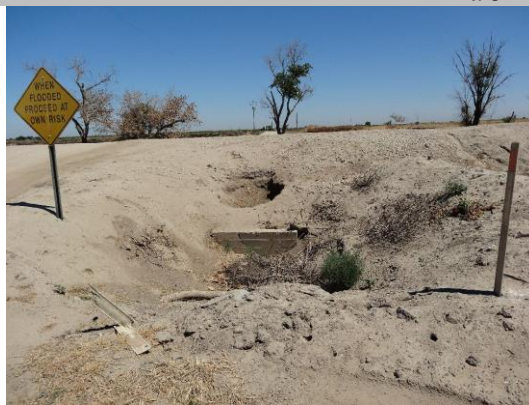
Photo 2 of 3 : UCIP_SP_2017_49977_75761.jpg

Sink hole and concrete headwall damage is visible on LS.

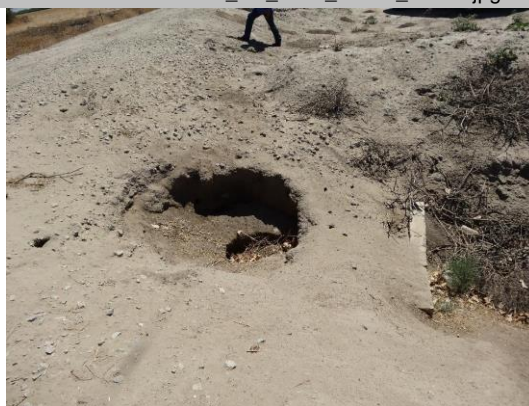
Photo 3 of 3 : UCIP_SP_2017_49977_75762.jpg

Sink hole located immediately above concrete headwall visible on LS.

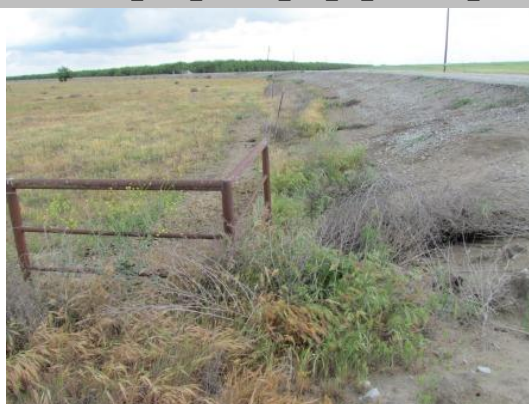
Photo 1 of 1 : SP_2017_NA0011_145_56_20170404_00011.jpg

Fence within the 10-foot of levee toe. This encroachment was recorded on 11-01-2012. Photo was taken 4-24-2014.

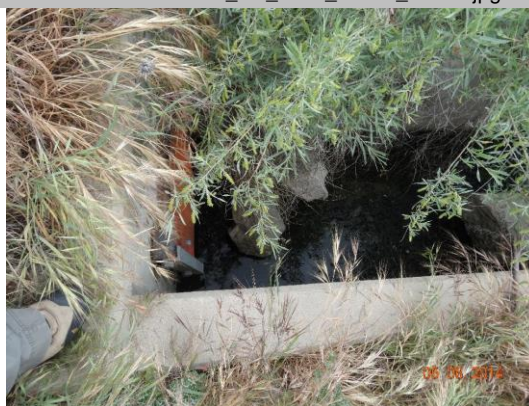
Photo 2 of 3 : UCIP_SP_2017_38235_69721.jpg

Concrete headwall visible on waterward side and covered by dense vegetation.

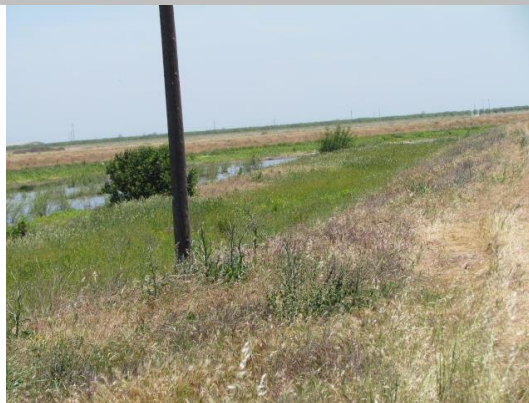
Photo 1 of 1 : SP_2017_NA0011_147_11_20170518_00034.jpg

Fresno River levee mile 0.01 looking upstream wild weed growth present on the slope and shoulder.

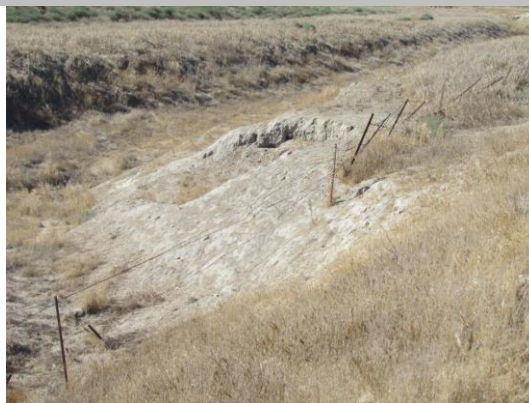
Photo 1 of 1 : SP_2017_NA0011_147_20_20170404_00005.jpg

Looking upstream at the old erosion site landside slope.

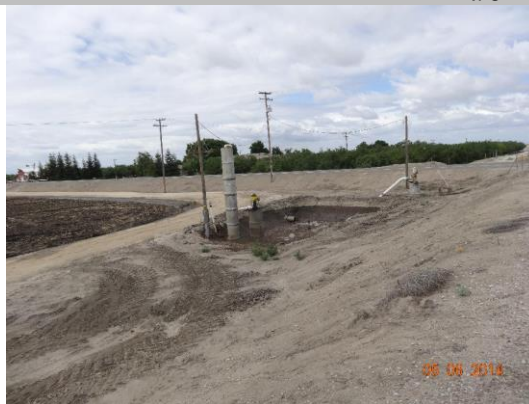
Photo 3 of 3 : UCIP_SP_2017_49980_69723.jpg

Additional structures found on LS.

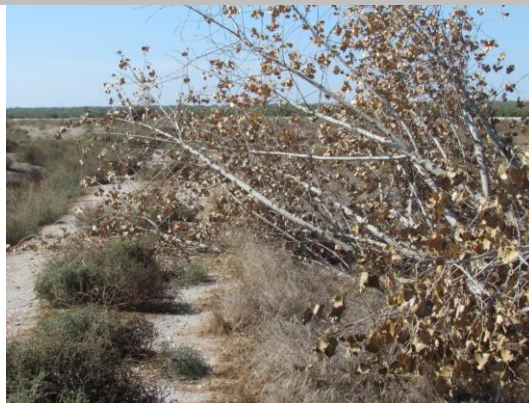
Photo 1 of 2 : SP_2017_NA0011_147_36_20170404_00010.jpg

Dead tree pushed upon the waterside slope and blocking the crown.

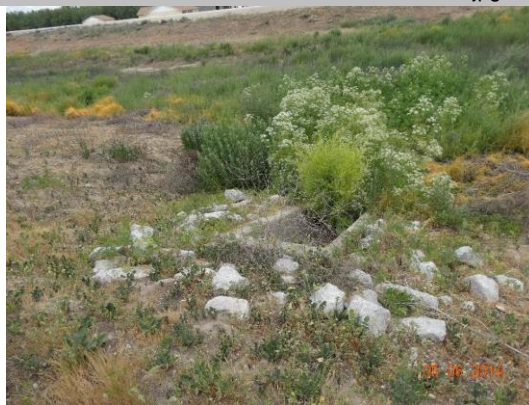
Photo 2 of 3 : UCIP_SP_2017_35806_64599.jpg

Rip rap around concrete headwall located on waterward side.
